Energy saving potential within MSMEs engaged in Textile Dyeing

Case Study 1: Company A

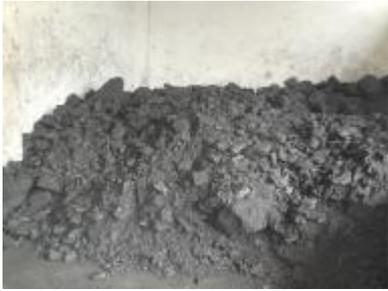
2.	<p>Improper size coal and big lumps of coal were being fed to the boiler. High un-burnt coal losses were observed.</p>

<p>Three possibilities are proposed: To purchase pre crushed coal from coal supplier OR Train the operator to crush the coal in proper size & instruct him to avoid large coal lumps to be fed to the boiler OR Install a coal crusher machine with mesh to avoid heavy lumps being fed to the boiler.</p>
<p>Cost of Intervention: Nil (for first 2 options) or Rs. 1,25,000 (for third option) Potential Annual Saving: Rs. 2,80,000 (35 t of coal) Payback Period: Immediate (for first 2 options) or 6 months (for third option)</p>

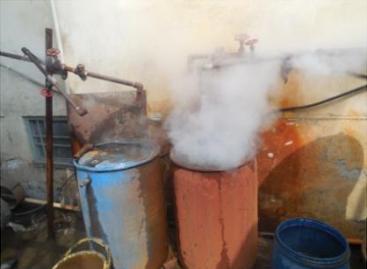
S.No.	Prevalent Situation	Recommended Changes
1.	<p>No condensate was recovered. Hot water at 96°C was flowing into drain, however a drum was kept to store it but it was overflowing and not being reused to feed into the boiler.</p>

<p>To install insulated drums and store the condensate hot water properly, use it to feed the boiler feed water tank. This would increase the feed water tank temperature and help in decreasing the coal consumption, & also reduce water consumption.</p>
<p>Cost of Intervention: 15,000 Potential Annual Saving: Rs. 21,500 (2.5 t of coal) Payback Period: 2 months</p>
